# Spindle Analysis

Date : 07-05-2016	Prepared by: J.Sorenson
Customer-Form_Precise_3 <sup>rd</sup> -party_rev3	Reviewed by: D. Kranz

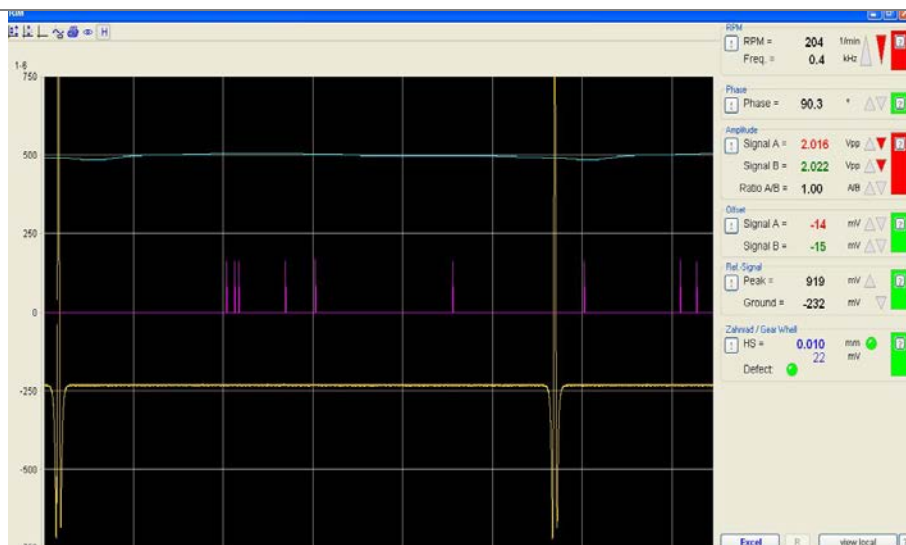
#### 5.4 Tachometer / encoder:

Encoder amplitudes are out of spec. Reading 2V peak to peak during testing.

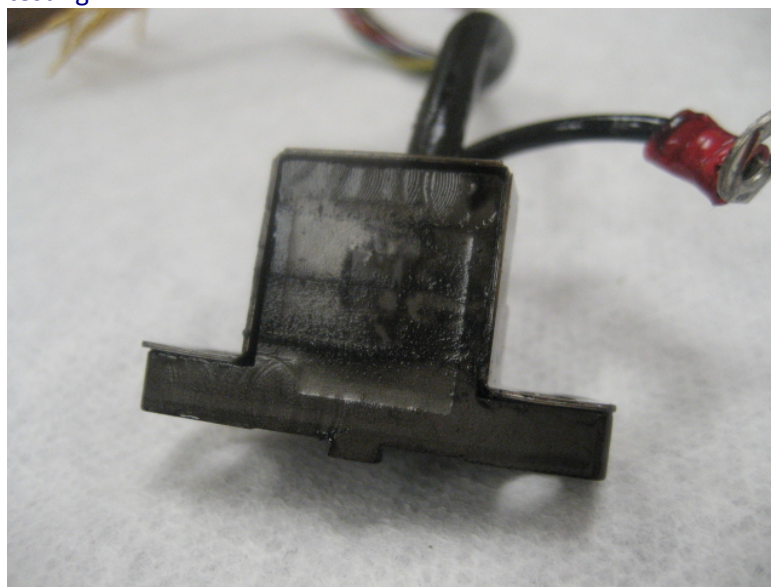
Encoder heavily contaminated.

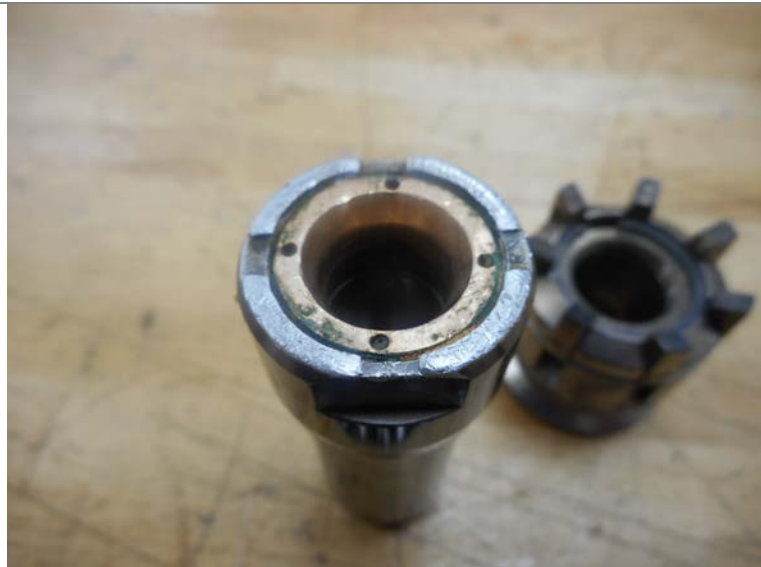
6.3 Drawbar (2,3,4 only):

Damaged from high vibrations.

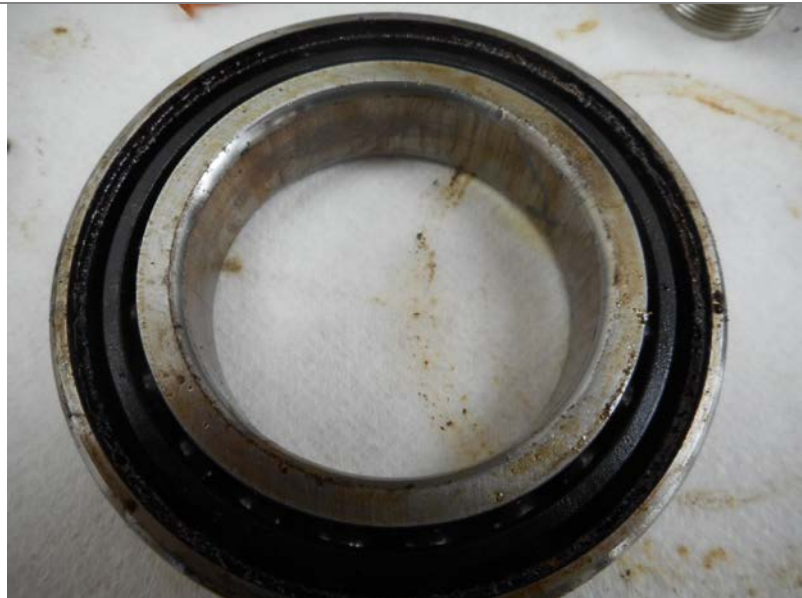
9.2	Middle Bearings:	N/A
9.3	Rear Bearings :	Fretting corrosion and contamination.

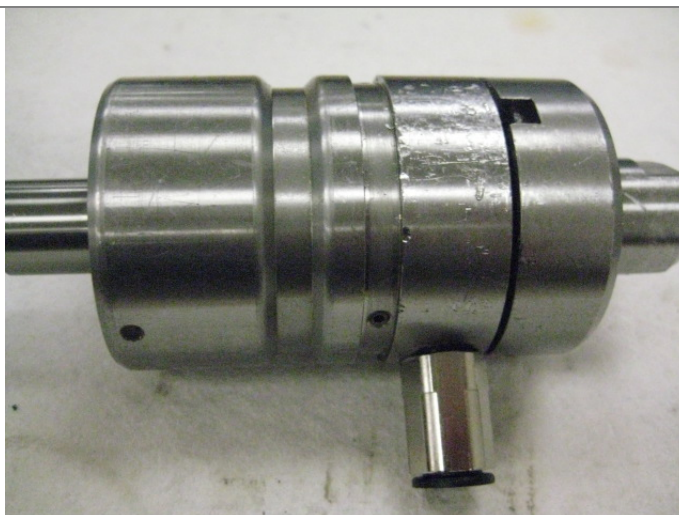
### 11.1 Bearings

Hard to turn.

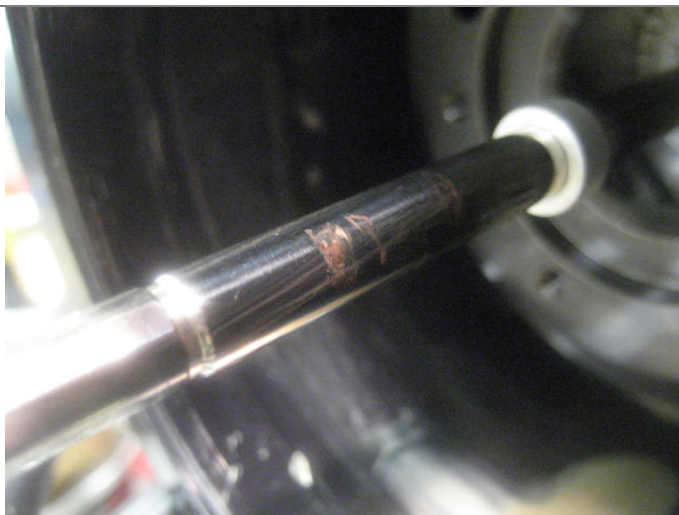
### 11.2 Seals:

Transition piece damaged from high vibrations.

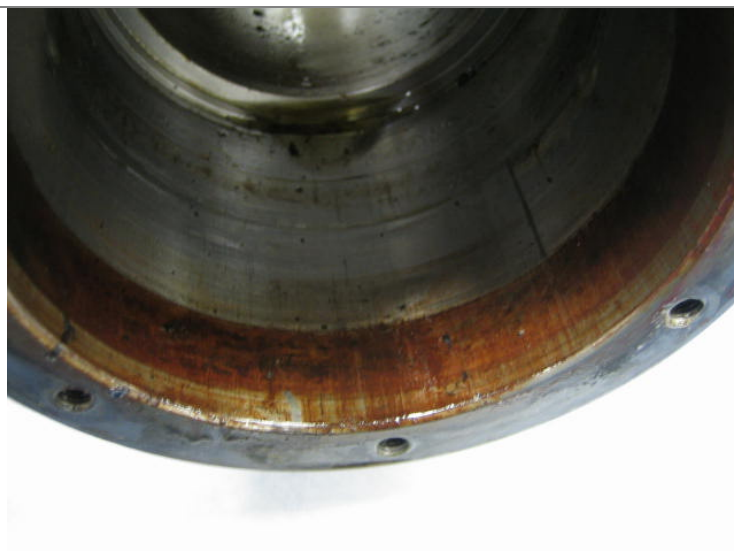
13.2 Cooling passages: Heavily corroded cooling passages.

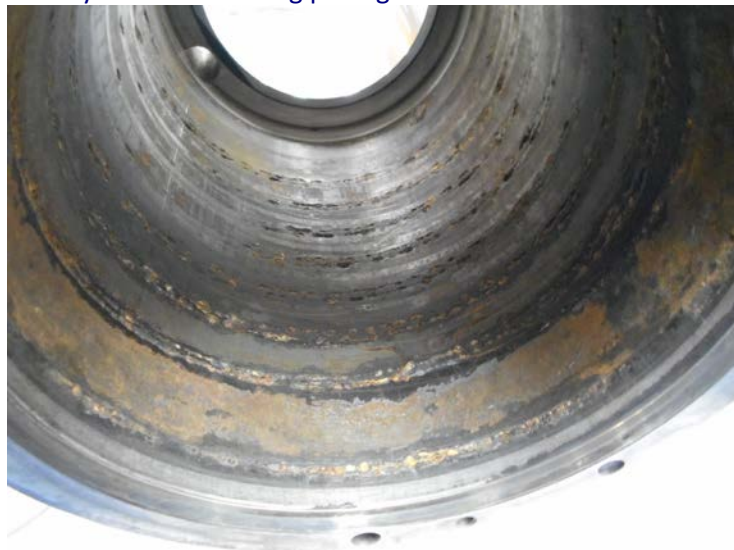
#### 14. Stator Jacket / Cooling Sleeve

Stator Sleeve Condition: Jacket is corroded from poor cooling water quality.

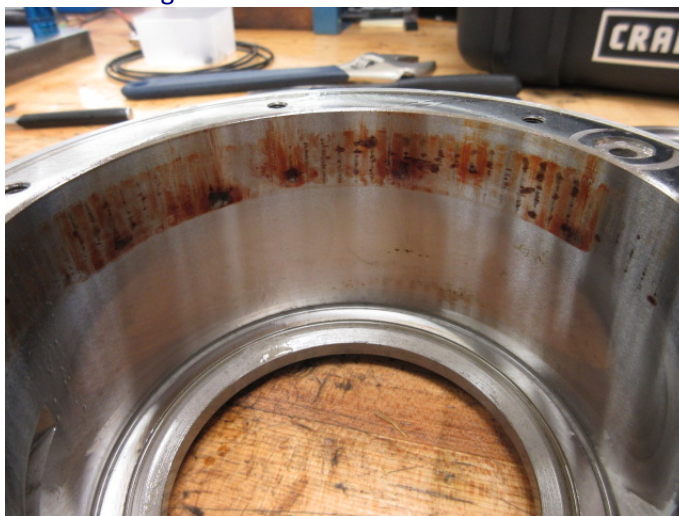
#### 16. Front Bearing Carrier

Not ok. Front carrier cooling passaged plugged and severely corroded.

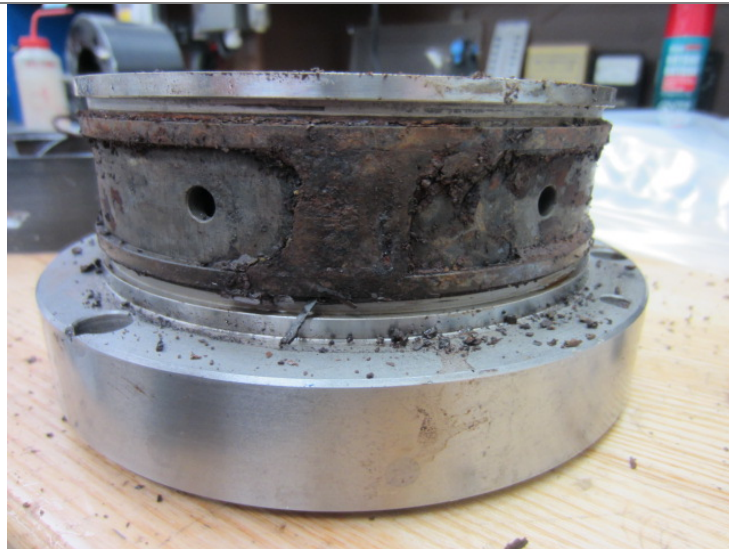
16.1 Front Cover / Labyrinth

Damaged from contact in operation.

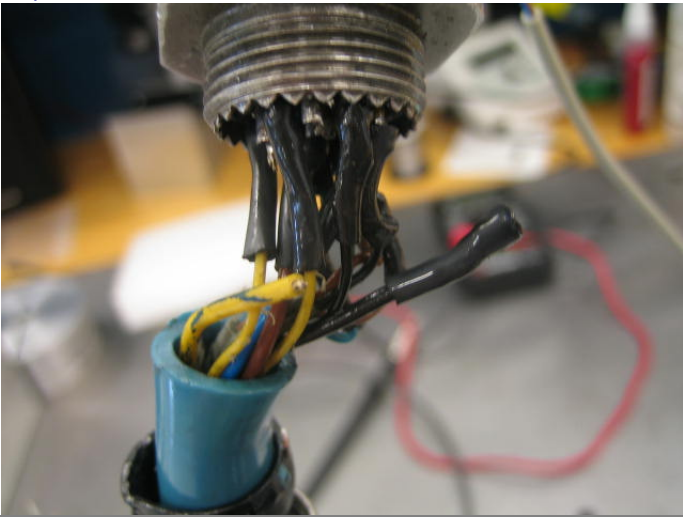
17.2 Cables:	<p>Replace oil soaked.</p>

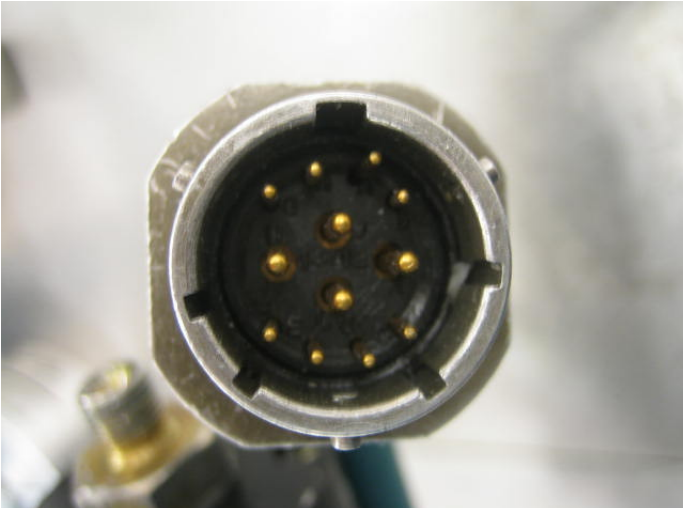
17.3 Connectors:	<p>Wear and tear but okay to use.</p>
