# Spindle analysis

Spindle analysis number: 4000000

Spindle number: 12345678

Spindle group: 3rd Party Spindle

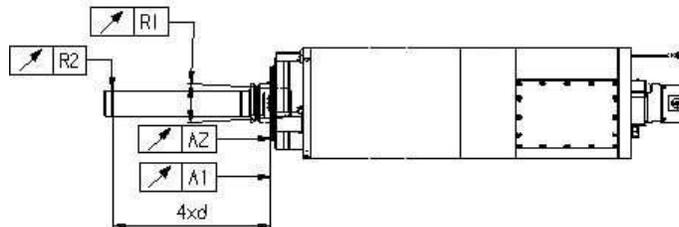
Run out check :

Runout:

Shaft is hard to turn

Nominal value R1: 0.003mm

Actual value R1: 0.003 mm

Nominal value R2: 0.01mm

Actual value R2: 0.0012 mm

Nominal value A1: 0.001mm

Actual value A1: 0.002 mm

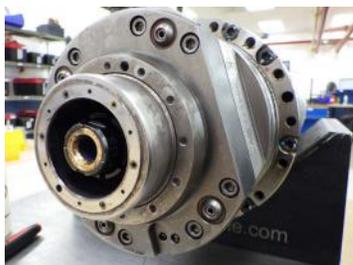
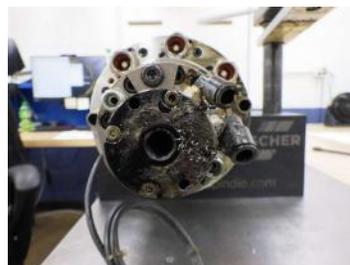
<b>Spindle in original condition:</b>				<input type="checkbox"/> / <input type="checkbox"/>
<b>Motor:</b>	Synchronous	Not ok		<input type="checkbox"/> / <input checked="" type="checkbox"/>
<b>EMF Voltage (phase-phase):</b>	Nominal value: 26.5 V eff/1000min-1	Actual value: 13.4 V eff/1000min-1		<input type="checkbox"/> / <input checked="" type="checkbox"/>
<b>Cable length:</b>	U1: m U2: m Grounding: m	V1: m V2: m Encoder type: m	W1: m W2: m Sensor: 2.0 m	
<b>PT-100:</b>	Available	Quantity: 2		<input checked="" type="checkbox"/> / <input type="checkbox"/>
<b>Spindle growth system DMD:</b>	Not available			<input type="checkbox"/> / <input type="checkbox"/>
<b>Acceleration sensor:</b>	Not available			<input type="checkbox"/> / <input type="checkbox"/>
<b>Taper blow out:</b>	All right			<input checked="" type="checkbox"/> / <input type="checkbox"/>
<b>Protecting air :</b>	All right			<input checked="" type="checkbox"/> / <input type="checkbox"/>

<b>Cooling water circuit:</b>	Pressure loss: 0 bar Water in spindle: Plugged:	Within: 30 min Contaminated: Plugged:		<input checked="" type="checkbox"/> / <input type="checkbox"/> <input type="checkbox"/> / <input type="checkbox"/> <input type="checkbox"/> / <input type="checkbox"/>
<b>Coolant through unit:</b>	Available	Leaking		<input type="checkbox"/> / <input checked="" type="checkbox"/>
<b>Clamping force :</b>	Nominal value: 18kN	Actual value: 19.6 kN		<input checked="" type="checkbox"/> / <input type="checkbox"/>
<b>Set point:</b>	Nominal value: 10.5+/-0.1mm	Actual value: 10.46 mm		<input checked="" type="checkbox"/> / <input type="checkbox"/>
<b>Acoustic bearing test:</b>	Rough			<input type="checkbox"/> / <input checked="" type="checkbox"/>
<b>Complete spindle disassembly:</b>	Yes <input checked="" type="checkbox"/>	No <input type="checkbox"/>

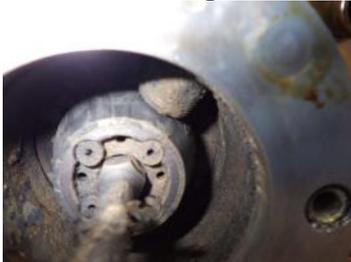
Analog

<b>Remarks:</b>	Contamination from leaking coolant through unit on analog sensor.

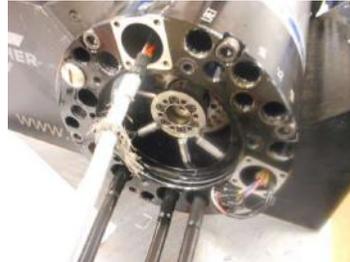
PNP

<b>PNP:</b>	Sensor S1: Wear and tear		<input checked="" type="checkbox"/> / <input type="checkbox"/>
	Sensor S2: Wear and tear		<input checked="" type="checkbox"/> / <input type="checkbox"/>
	Sensor S3: Wear and tear		<input checked="" type="checkbox"/> / <input type="checkbox"/>
	Sensor S4: Wear and tear		<input checked="" type="checkbox"/> / <input type="checkbox"/>
	Sensor S5: Not available		<input type="checkbox"/> / <input type="checkbox"/>
<b>Analog:</b>	Sensor A1: actual value: / target value: 3800		<input type="checkbox"/> / <input type="checkbox"/>
	Sensor A2: actual value: / target value: 3800		<input type="checkbox"/> / <input type="checkbox"/>
	Sensor A1: Wear and tear	Contaminated	<input type="checkbox"/> / <input checked="" type="checkbox"/>
	Sensor A2: Not available		<input type="checkbox"/> / <input type="checkbox"/>
<b>Analog controller:</b>	Not available	No.:	<input type="checkbox"/> / <input type="checkbox"/>

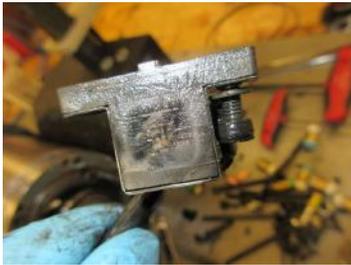
**Remarks:** Contamination on encoder. Encoder wheel tests OK after cleaning.

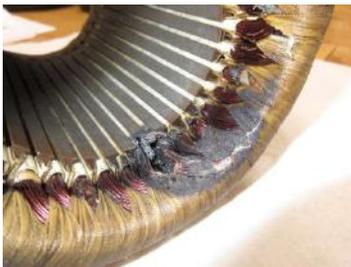
**Stator windings comparison:** Windings are damaged  /

**Stator leakage current:** Stator is grounded  /

**Remarks:** Stator windings shorted to ground.

Component causing failure: Electric drive

**Main breakdown reason:** Overload  
 Shaft rotor demagnetized / mechanical damage from carbon wrap coming apart. Vibration damage to bearings and clamping system. Cooling circuit heavily contaminated.

**Proposed solutions:** Spindle repair  
 Recommend checking cooling system for proper cleanliness / concentration. Clean and flush as needed. Check cables / connections to motor in case of electrical damage from failure.

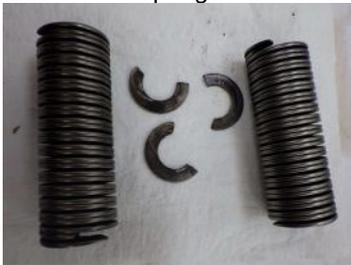
Springs

<b>Gripper segment:</b>	Wear and tear	Vibration Damage	<input type="checkbox"/> / <input checked="" type="checkbox"/>
<b>Valve block:</b>	All right		<input checked="" type="checkbox"/> / <input type="checkbox"/>
<b>Clamping force:</b>	All right		<input type="checkbox"/> / <input type="checkbox"/>
<b>Springs:</b>	Wear and tear	Broken	<input type="checkbox"/> / <input checked="" type="checkbox"/>
<b>Drawbar:</b>	Wear and tear	Vibration Damage	<input type="checkbox"/> / <input checked="" type="checkbox"/>
<b>Threaded rod:</b>	Not available		<input type="checkbox"/> / <input type="checkbox"/>
<b>Chucking lever shaft:</b>	Not available		<input type="checkbox"/> / <input type="checkbox"/>
<b>Unclamping unit:</b>	Not available		<input type="checkbox"/> / <input type="checkbox"/>
<b>Lubrication:</b>	Contaminated		<input type="checkbox"/> / <input checked="" type="checkbox"/>

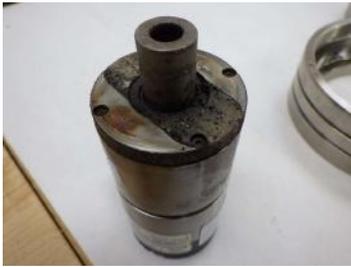
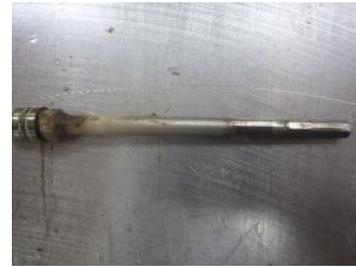
DDF/OTT  
Transition piece (OTT)

Leakage  
Mechanical damage

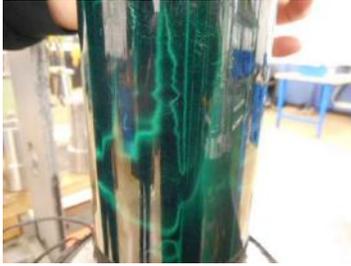
R.12: Nominal value: 0.002mm Actual value: 0.005 mm  /

R.1: Nominal value: 0.002mm Actual value: 0.003 mm  /

Shaft rotor demagnetized, carbon wrap damaged. Green LCD paper shows demagnetized area of rotor. Fretting corrosion on front bearing journal. Shaft will be replaced.

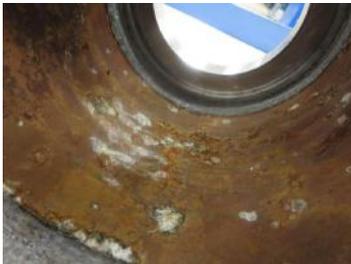
Visual check outside:	All right	<input checked="" type="checkbox"/> / <input type="checkbox"/>
Visual check inside:	Contaminated	<input type="checkbox"/> / <input checked="" type="checkbox"/>
Bearing seat:	Not available	<input type="checkbox"/> / <input type="checkbox"/>
Remarks:	Rust / scale in cooling water passages.

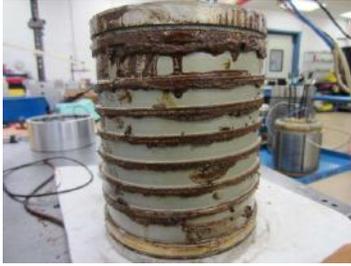
Available:	Yes <input checked="" type="checkbox"/> No <input type="checkbox"/>	
Visual check outside:	Contaminated	<input type="checkbox"/> / <input checked="" type="checkbox"/>
Visual check inside:	All right	<input checked="" type="checkbox"/> / <input type="checkbox"/>
Bearing seat:	Not available	<input type="checkbox"/> / <input type="checkbox"/>
Remarks:	Rust / scale on cooling water passage.

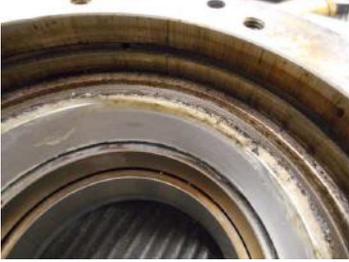
Bearing seat

- Available:** Yes  No
- Visual check outside:** All right  /
- Bearing seat:** Fretting corrosion  /
- Water circulation:** Contaminated  /
