# Spindle Analysis

Date : 07-05-2016	Prepared by: J.Sorenson
Customer-Form_Precise_3 <sup>rd</sup> -party_rev3	Reviewed by: D. Kranz

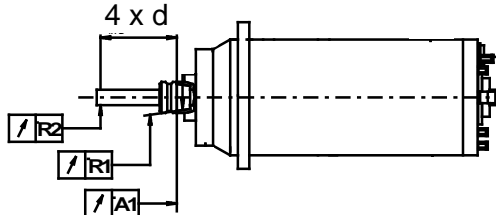
Can shaft be turned freely?			YES	X	NO			
	Run out			Measured Value					
	R1 (shaft taper/bore) max .003			0.005 mm					
	R2 (test arbor)			0.010 mm					
	A1 (shaft face)			0.003 mm					
	Clamping System								
	Clamping Force			13.2 kN					
	Electrical								
	Hi-Pot Test			Pass	X	Fail			
	Ground-bond Test			Pass	X	Fail			
	Cooling Circuit								
	Flow Rate			OK	X	Low		None	
	Leak Test			OK		X	Leaks		
	Additional Comments:								
	Spindle bearings feel rough when turning shaft by hand.

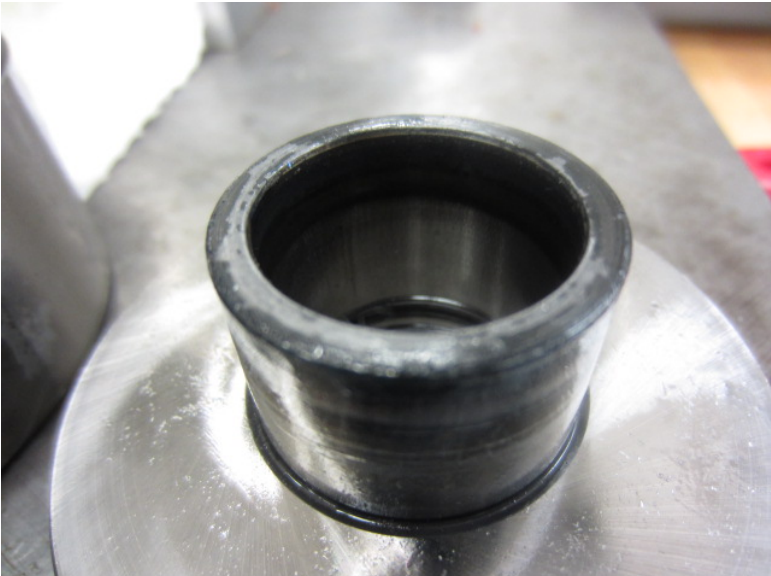
<b>ATC Cylinder Condition:</b>		<b>OK</b>
10.1	O-rings / Quad rings / O-rings	<b>Wear and tear.</b>
10.2	Piston Rod:	<b>Damaged from contact with rotating component in operation.</b>

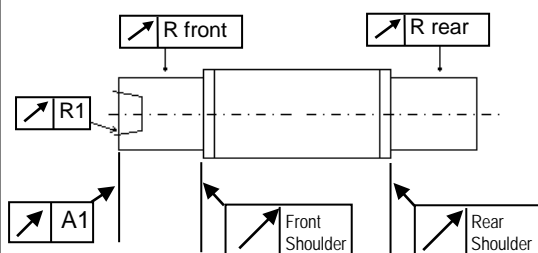
## 12. Shaft (disassembled)

Run out	Tolerance		Measured Value
R1 (taper/bore)	0.003	mm	0.006 mm
A1 (face)	0.001	mm	0.002 mm
R-front diameter	0.003	mm	0.008 mm
R-rear diameter	0.003	mm	0.0025 mm
R-front shoulder	0.001	mm	0.0045 mm
R-rear shoulder	0.001	mm	0.005 mm
<b>Shaft Condition:</b>		Bearing journals damaged from fretting corrosion.

Major components recommended to be replaced:	Cause of component failure:
• Rotary union	Failed bearings.
• Bearings	Fretting corrosion.
• Clamping system	Broken springs, worn gripper.
• Shaft	Fretting corrosion. Shaft will be refurbished.
• Front Bearing Carrier	Corroded.

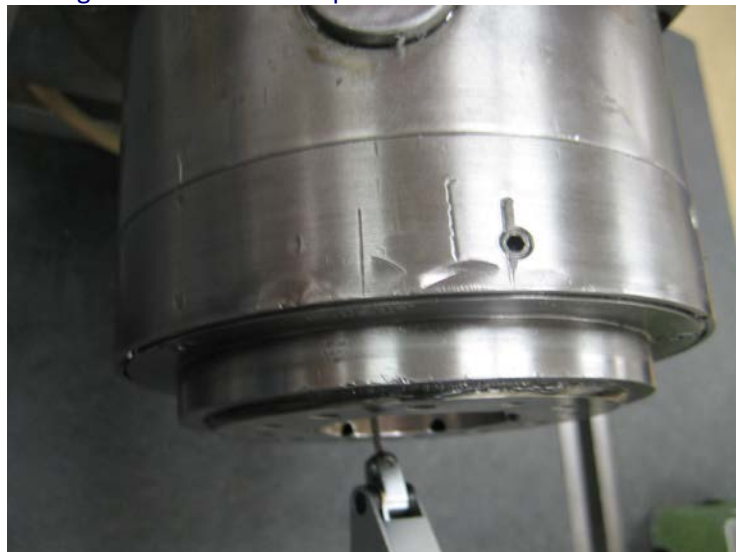
16.1 Front Cover / Labyrinth

Damaged from contact in operation.
